WEST HARRISON FIRE DEPARTMENT
95 LAKE STREET
WEST HARRISON, NY 10604-9943
WWW.WESTHARRISONFD.ORG

RE: Town Board Meeting of May 4, 2023

INSPECTION REPORT

West Harrison Fire Department

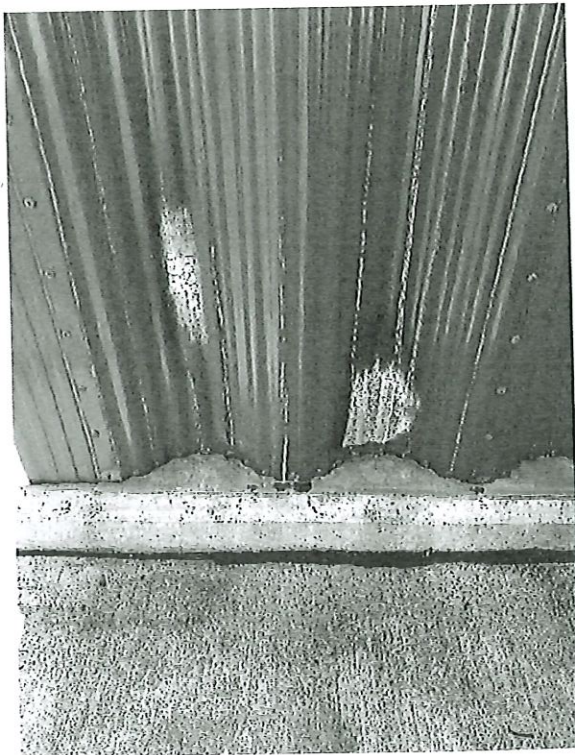
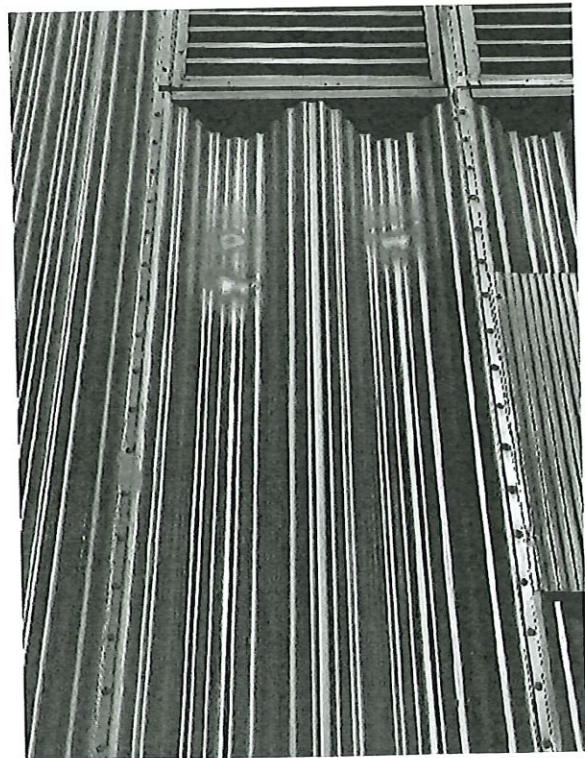
- The panels have several areas of heat damage. Fig 1, Fig 2

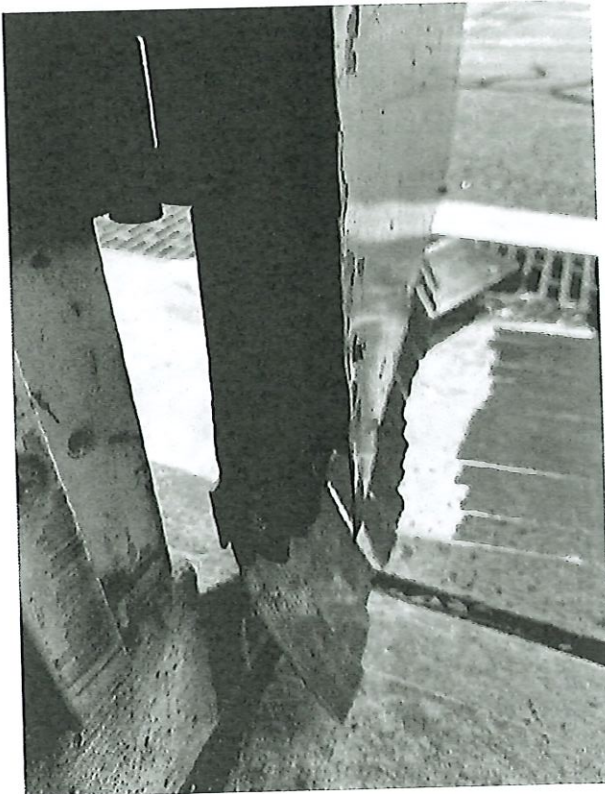
- Poor Condition
- Skin separating at lower hinge pocket. Fig 3
- Door sweeps worn and torn. Fig 4
- Knob does not work
- Slide bolt missing catch
- Hinges need lubricated

- 7.5 Install thermal liner on the joists outside of all interior burn room doors. (4-2X4 panels)
- 7.6 Replace 2 joists in 1st floor burn room.
- 7.7 Recommend replacing hollow double door with new steel plate doors and hardware.

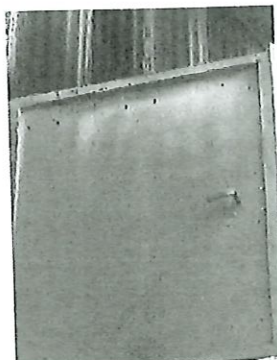
- Fair condition
- Heat damage Fig 5
- Surface rust Fig 5
- Hinge and handles need lubricated

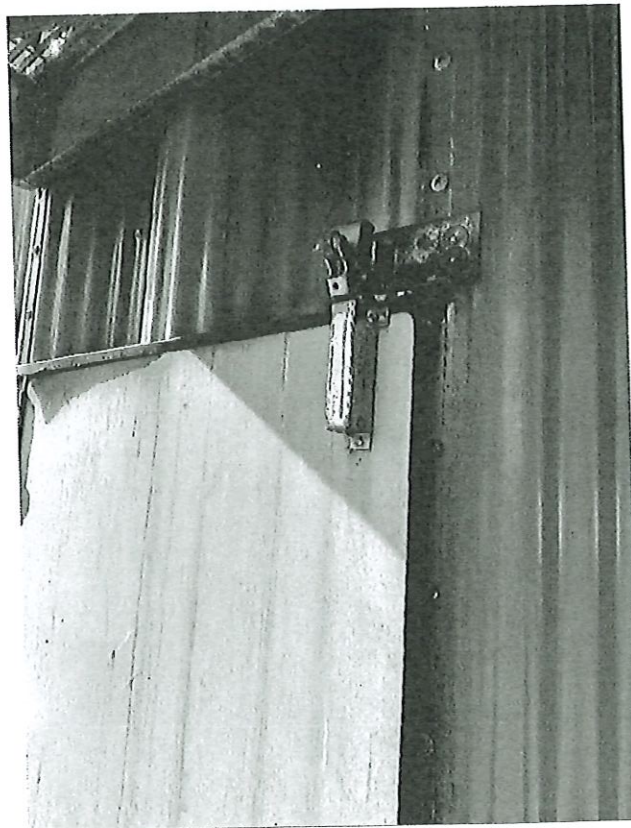
- Good condition
- Automatic closure needs to be adjusted to hold door closed.
- Door catch needs adjusted to function as it is intended. Fig 6
- Header rusted
- Hinges and hardware to be lubricated

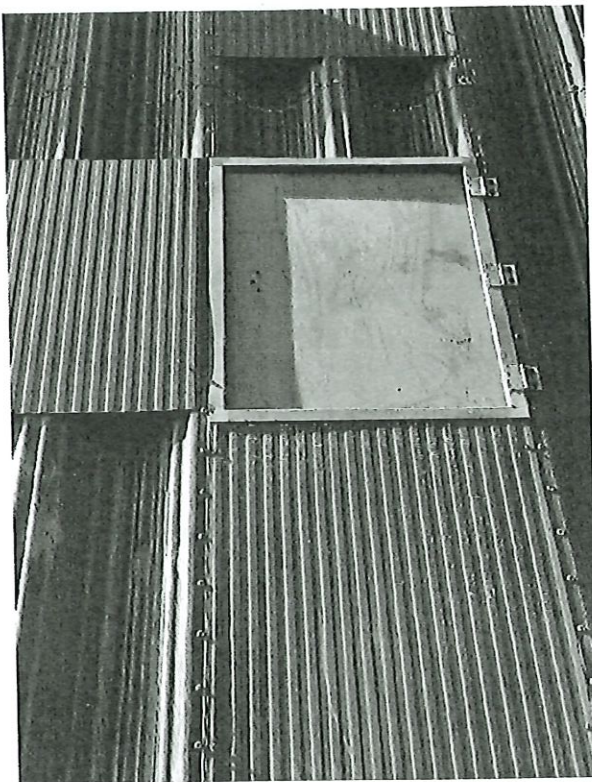
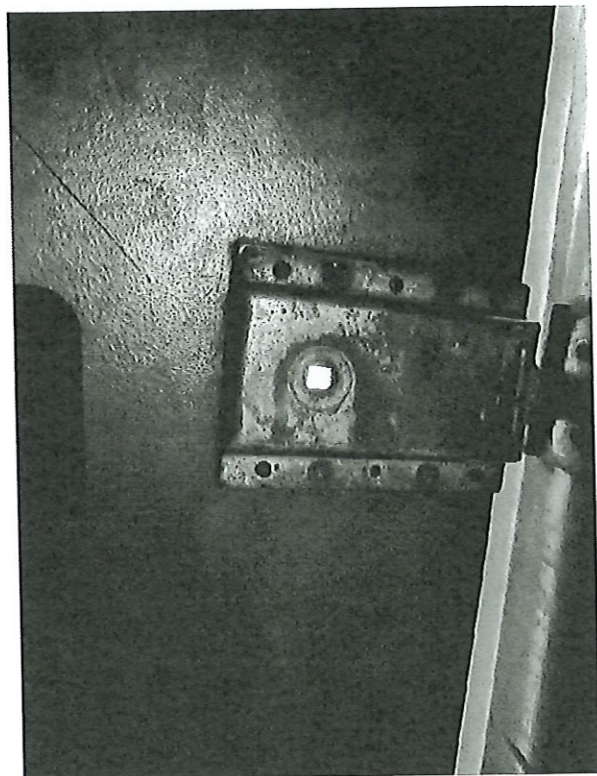
- Good condition
- Missing interior and exterior handles Fig 7, Fig 8
- Hinges and hardware need lubricated

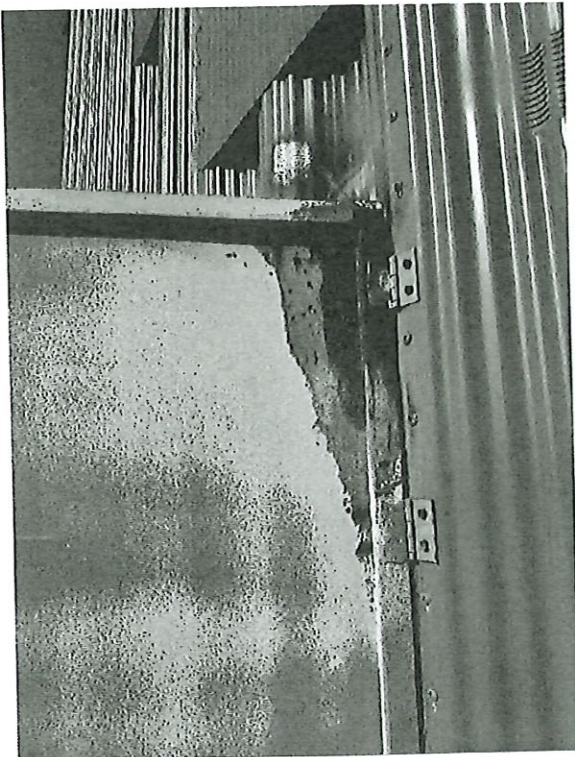
Fig 9

- Poor condition
- Heat damage and rust. Fig 9.
- Header burned and rusted thru. Fig 10
- Hinges and hardware need to be lubricated.

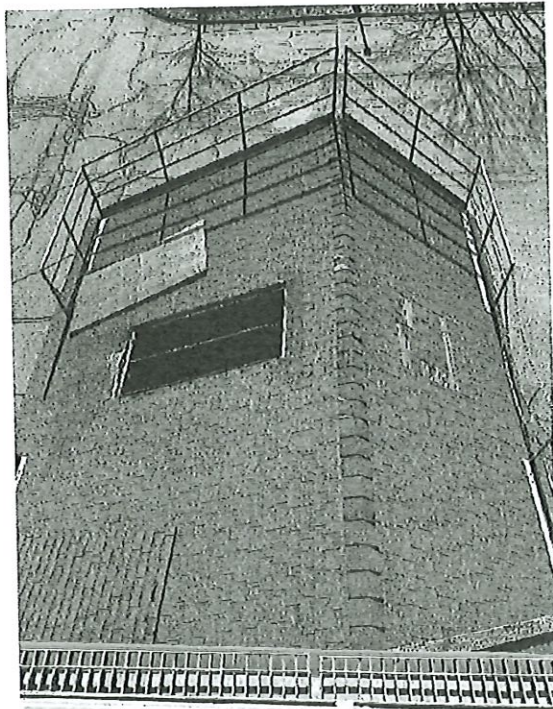
- Shingles torn/missing/damaged around chop outs and ridge cap. Fig 11
- Chop outs not stowed properly. Fig 11

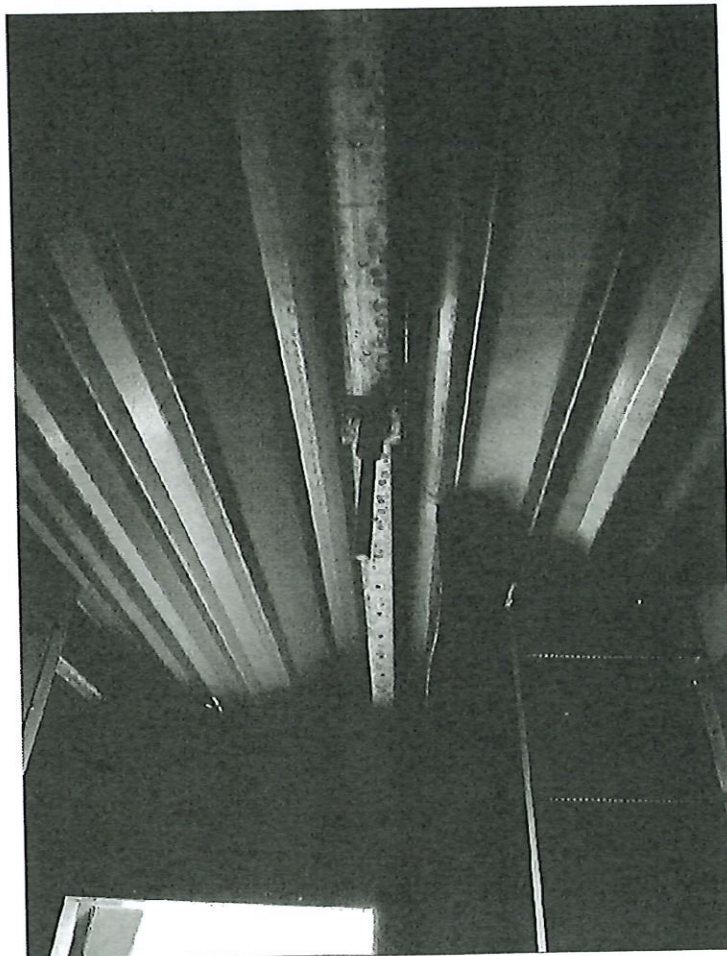
Fig 12

- A. Bar Grate- All connection points appear to be solid and secure.
- B. Rails- All connection points appear to be solid and secure.
- C. Deck Hatch- All connection points appear to be solid and secure.
- D. Chain Gates- All connection points appear to be solid and secure.
- E. Rappel Anchors (4)- Not installed to current industry standards. Fig 12.

- 7.8 Replace Pull handle on 2nd floor burn room door.
- 7.9 Install angle on joist side of rappel anchors. (2 long angles)
- 7.10 Replace broken/Inoperable slam latches and handle sets. (1)

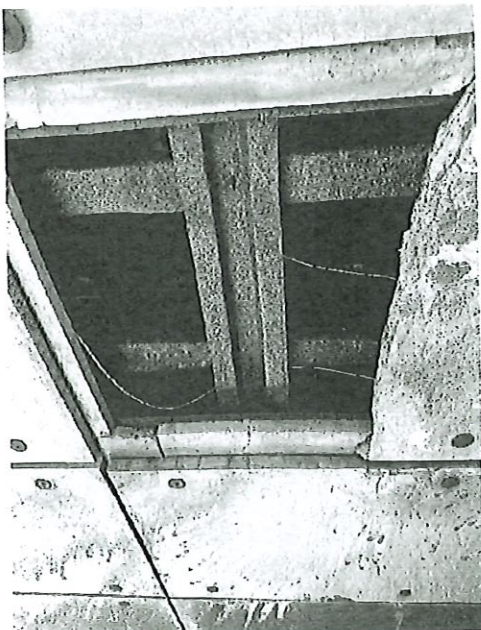
- 2 joists need replaced in 1st floor burn room. Fig 13
- Joists rusted outside of 1st and 2nd floor B.R.'s. Fig 14

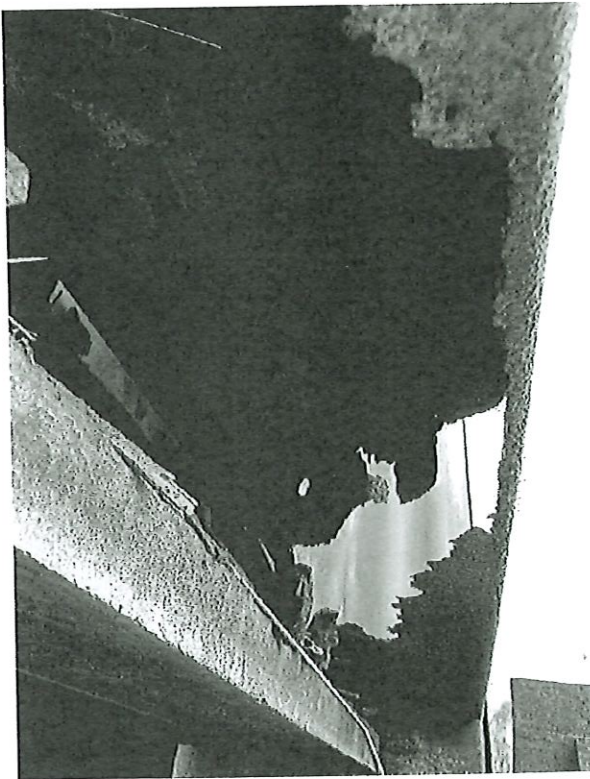
- Good overall condition
- Panel is burned and rusted over shutter in 1st Floor B.R. Fig 15

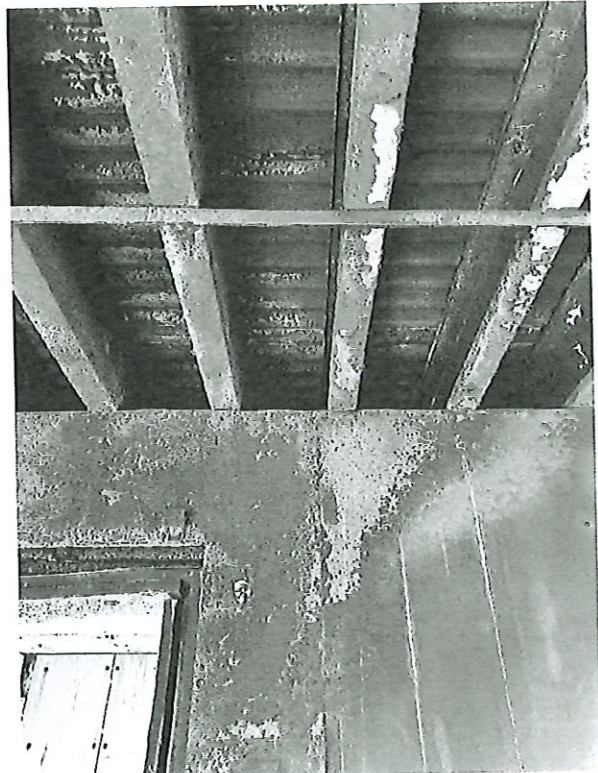
- Burned outside of 1st and 2nd floor B.R.'s. Fig 16

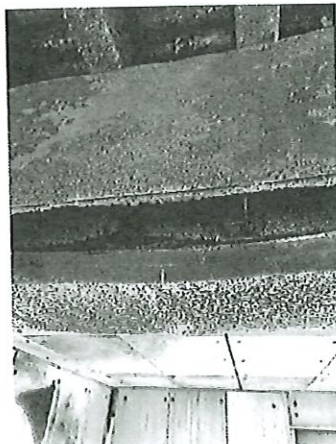
- Good condition
- Header is completely burned through. Fig 17
- Automatic closure needs to be adjusted to proper tension.

- 7.11 Replace one broken door knob set (locking)
- 7.12 Replace missing or torn door sweeps. (2)
- 7.13 Replace headers in 1st floor burn room. (1 interior and 1 exterior)

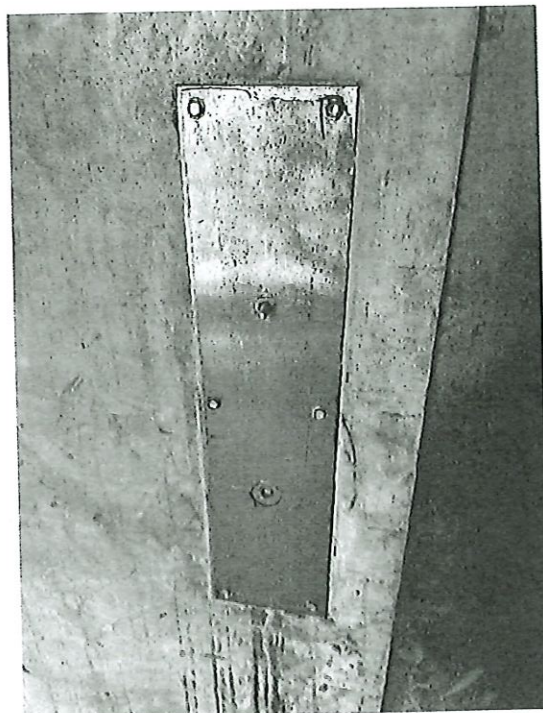
- Good condition
- Pull handle missing. Fig 18
- Hinge and hardware need lubricated.

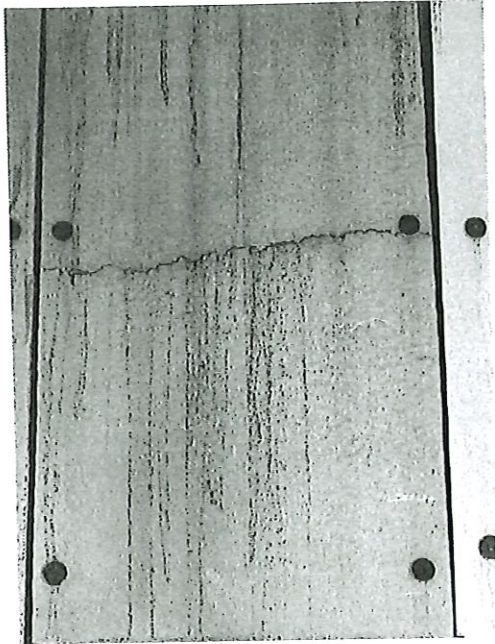
Fig 19

- 14 panels and associated battens need replaced. Fig 19.
- Lower perimeter battens need replaced around whole room. Fig 20.

- 7.1 Replace panels and battens on ceiling and walls in burn rooms. (Approx. 47-2X4 super padgenite panels and associated battens.)
- 7.2 Replace liner panels on Window Shutters (4-2x4 panels)

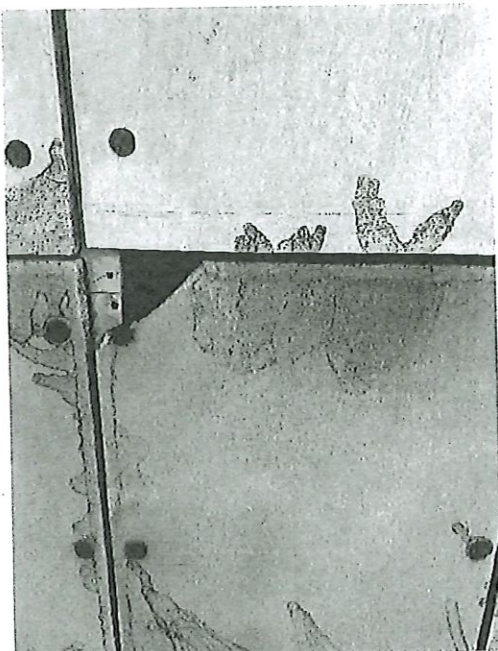
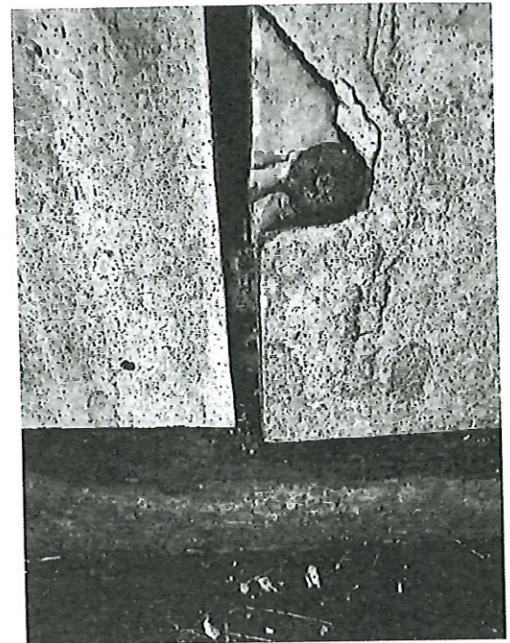
- 11 panels and battens throughout need replaced. Fig 21
- Hat channel rusted and warped at ceiling thermal breach location. Fig 22

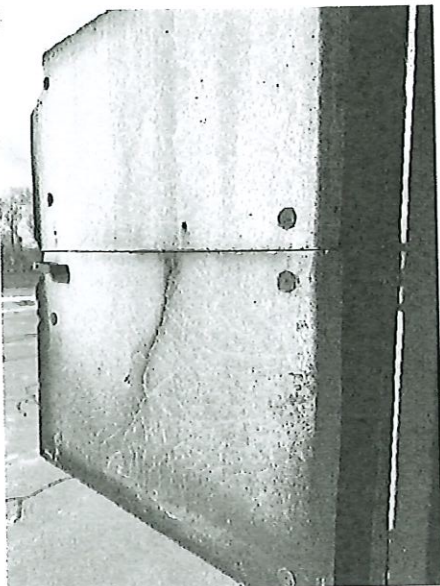
Fig 23

- Reline and re wrap is needed. Fig 23.

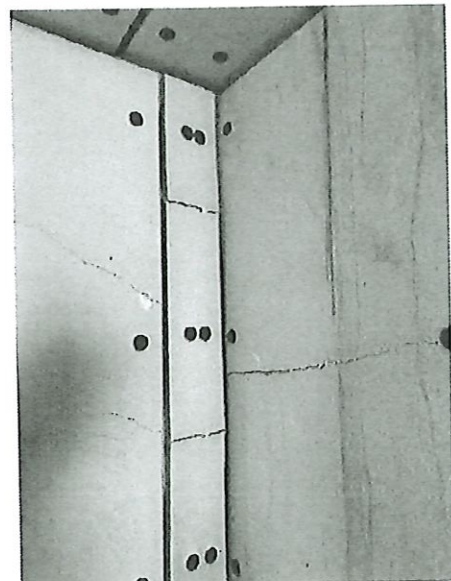
- 13 panels and associated battens need to be replaced. Fig 24

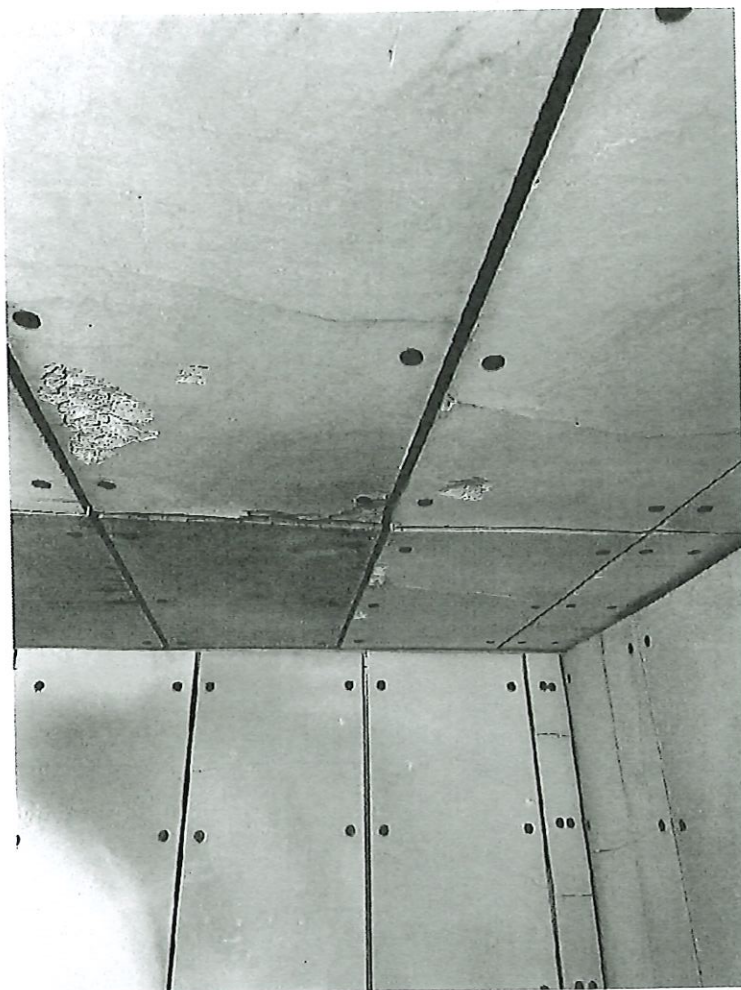
- 9 panels and associated battens need to be replaced. Fig 25

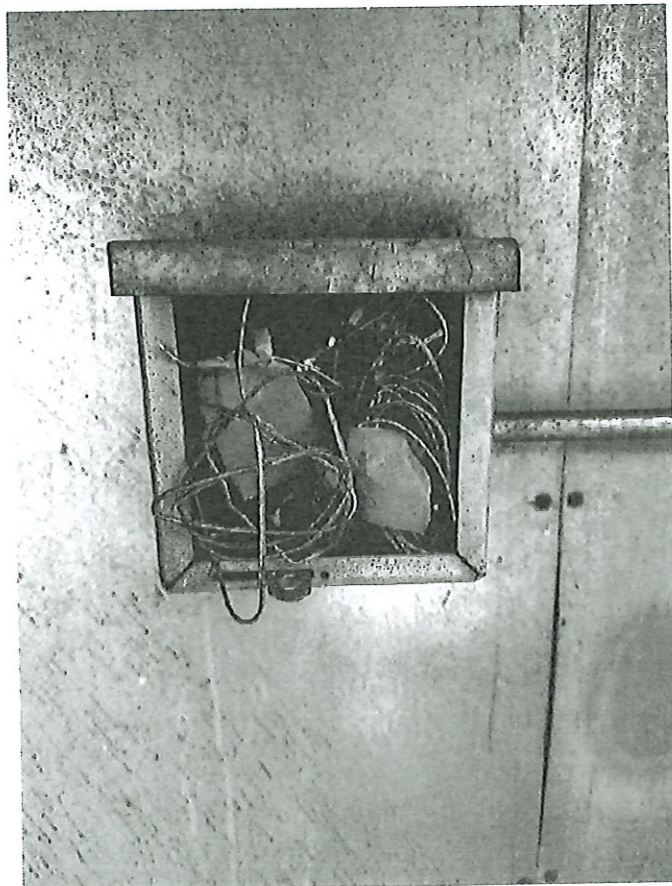
Fig 26

- Was not tested.
- Recommend upgrade and relocation of patch panel. Fig 26.

- 7.14 Recommend relocating and installing new patch panel.
- 7.15 Per NFPA 1402 Standard on Facilities for Fire Training and Associated Props 2019 version your burn rooms shall be inspected annually. This can be conducted as a self-inspection. Section 7.2.1 states "The structural integrity of live fire training structures shall be evaluated and documented annually by the owner/operator or AHJ".
