WEST HARRISON FIRE DEPARTMENT
95 LAKE STREET
WEST HARRISON, NY 10604-9943
WWW.WESTHARRISONFD.ORG

RE: Town Board Meeting of May 4, 2023

INSPECTION REPORT

West Harrison Fire Department

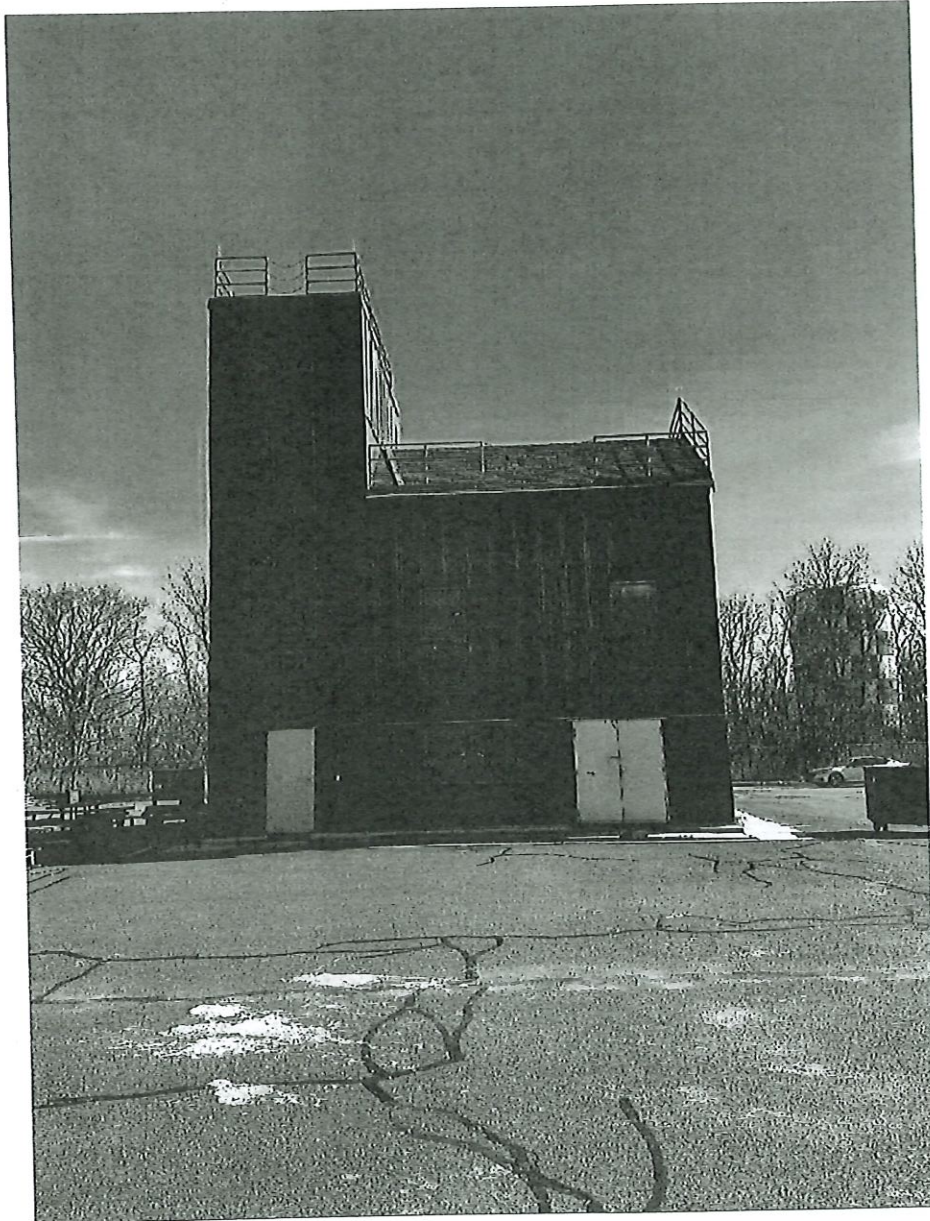
“A” Side Elevation

- Poor Condition
- Skin separating at lower hinge pocket. Fig 3
- Door sweeps worn and torn. Fig 4
- Knob does not work
- Slide bolt missing catch
- Hinges need lubricated

- Fair condition
- Heat damage Fig 5
- Surface rust Fig 5
- Hinge and handles need lubricated

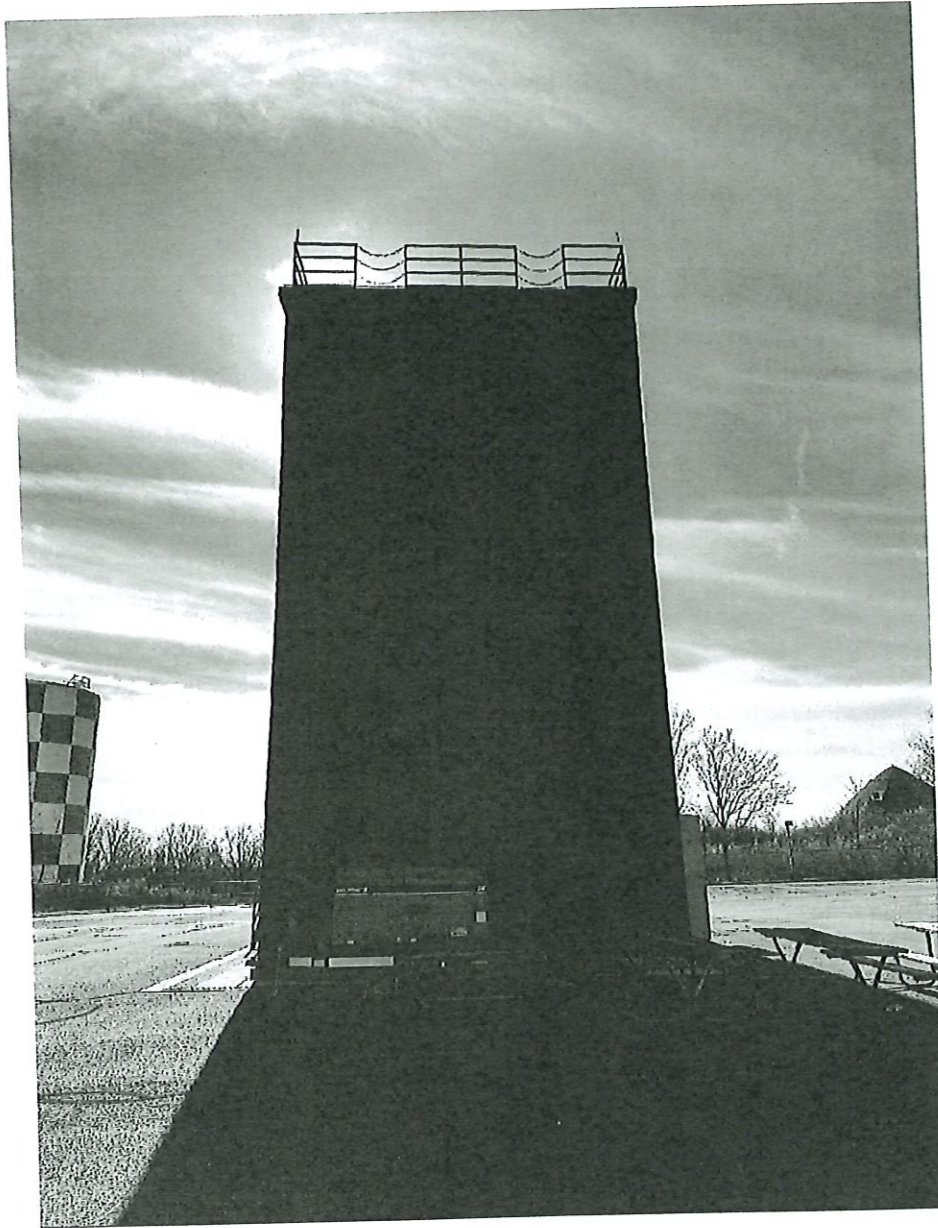
"B" Side Elevation

*No window shutters or doors to inspect

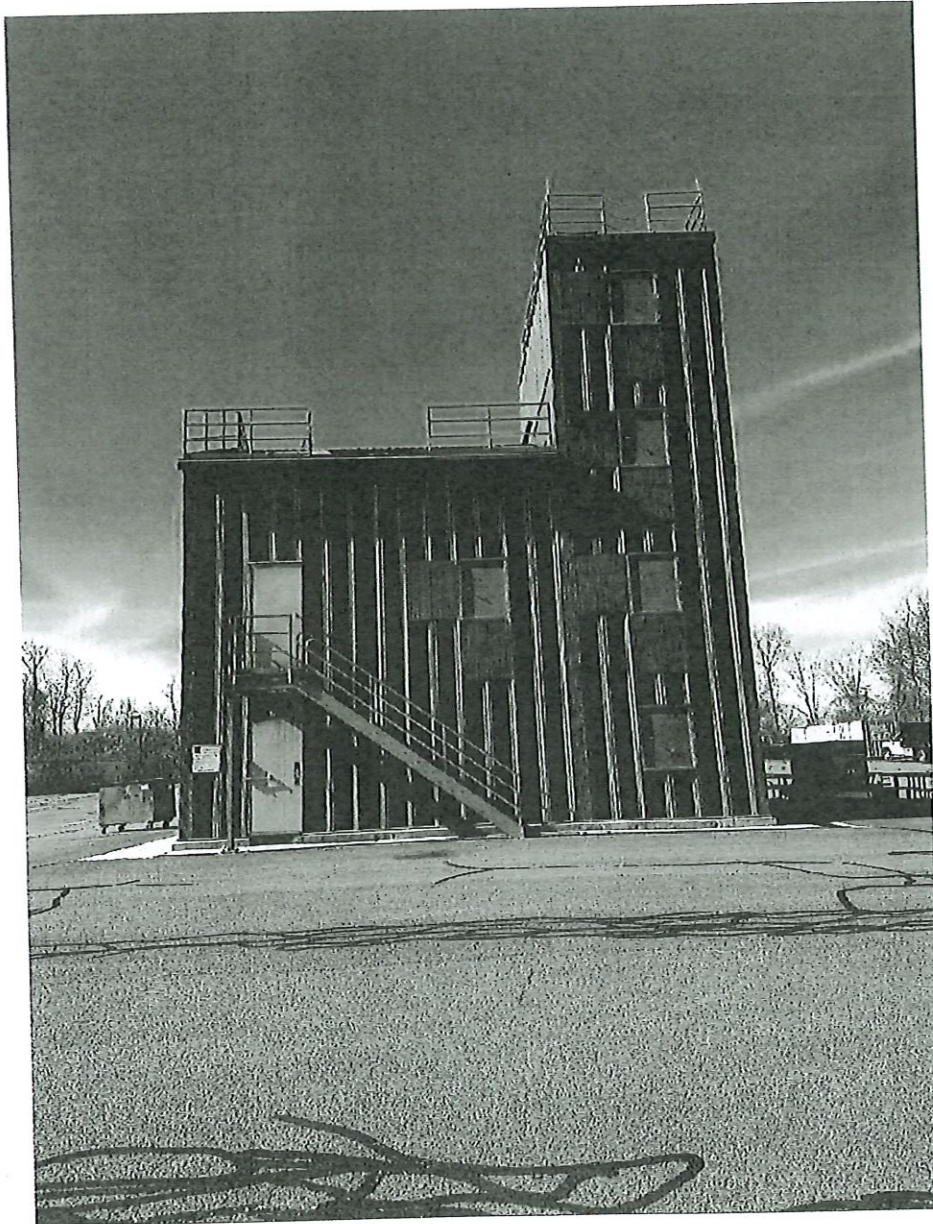
"C" Side Elevation

- Good condition
- Automatic closure needs to be adjusted to hold door closed.
- Door catch needs adjusted to function as it is intended. Fig 6
- Header rusted
- Hinges and hardware to be lubricated

- Good condition
- Header is bent
- Strike needs to be adjusted to properly secure the door when closed.
- Hinge and hardware need to be lubricated

- Good condition
- Missing interior and exterior handles Fig 7, Fig 8
- Hinges and hardware need lubricated

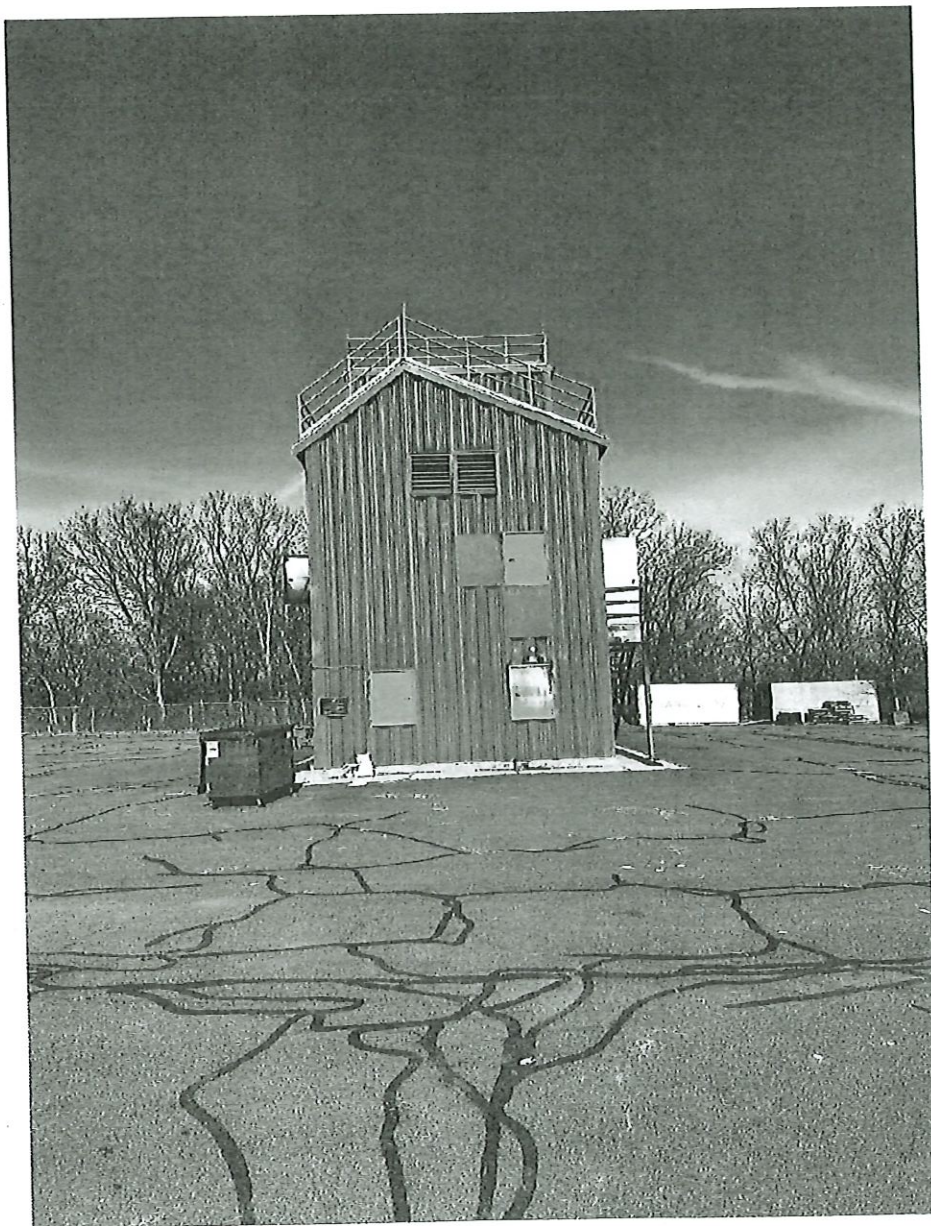
“D” Side Elevation

- Poor condition
- Heat damage and rust. Fig 9.
- Header burned and rusted thru. Fig 10
- Hinges and hardware need to be lubricated.

- Shingles torn/missing/damaged around chop outs and ridge cap. Fig 11
- Chop outs not stowed properly. Fig 11
